INTERPRETATION STUDY ON THE SITE OF FORMER MOUNTAIN LODGE AND ITS SURROUNDING AREAS

FOR ANTIQUITIES AND MONUMENTS OFFICE,
LEISURE AND CULTURAL SERVICES DEPARTMENT

Part 1 - Statement of Significance

December 2011
The Oval Partnership

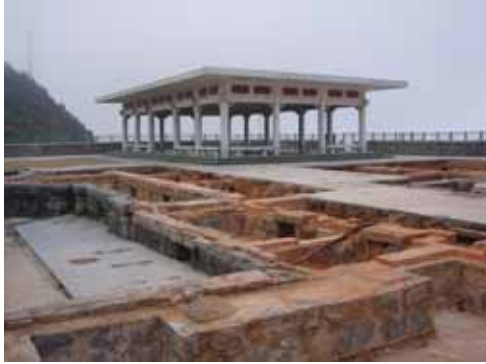
1. Site of the FML with exposed foundations looking towards the existing pavilion (Backfilled in March 2009)

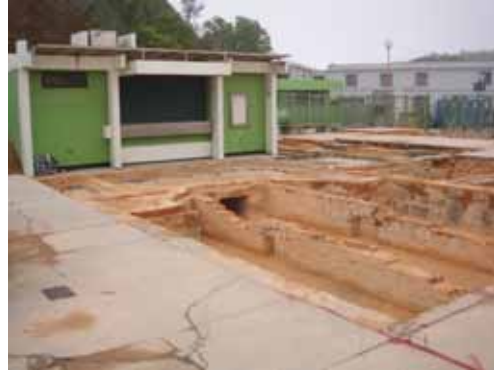
2. Site of the FML with exposed foundations looking towards the existing kiosk (Backfilled in March 2009)

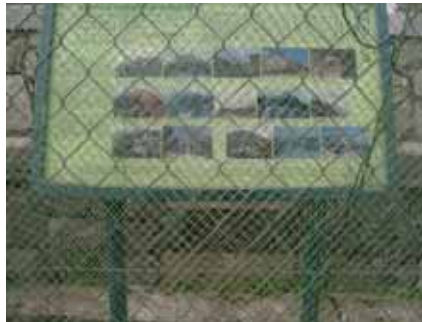
At present, there is one interpretative sign illustrating the historic residential construction on the Peak (see image below).

3. Interpretative sign at the FML site

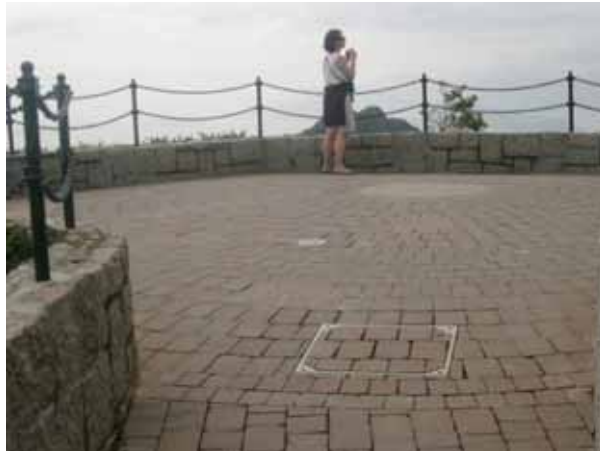
The immediate surroundings of the FML include two lookout points both of which offer spectacular views to the south and west. One of the vantage points is located directly above the FML foundations, while the other is a short walk, about 100 metres away from the foundations in the form of a circular viewing platform.

6. Circular viewing platform

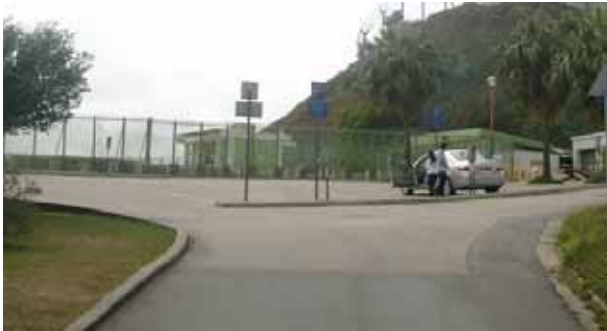
7. Access to the FML site and existing car park

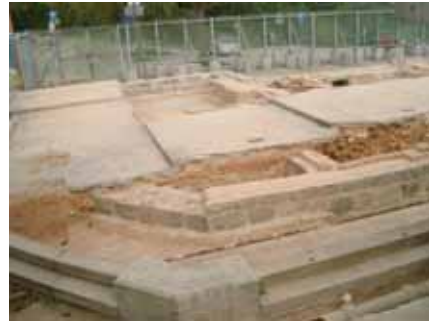
8. Exposed FML foundations under archaeological investigation in February 2009

Recently, improvement works for the FML and its surrounding areas were underway until 2006 when workers unearthed foundations of the FML. This discovery generated significant public and media interest (Chong 2007).

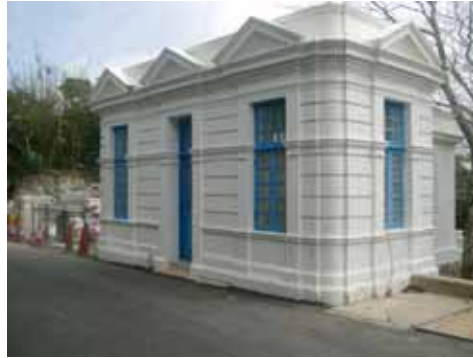
The former Gate Lodge originally served as the living quarters for the gatekeeper of the Former Mountain Lodge. It is a small building with a usable area of approximately 100 square feet and is the last remaining original remnant of the FML declared a monument in 1995. The Hong Kong Film Services Office has identified the Gate Lodge as a potential filming location, making reference to its renaissance style architecture (FSO 2008).

9. Gate Lodge

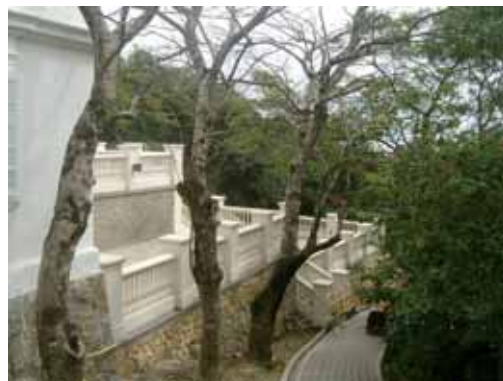
The recent improvement work included the restoration of the Gate Lodge while also enhancing the open space adjacent. As a result, a series of stepped terraces have been constructed behind the building.

10. Recent Construction of Terraces

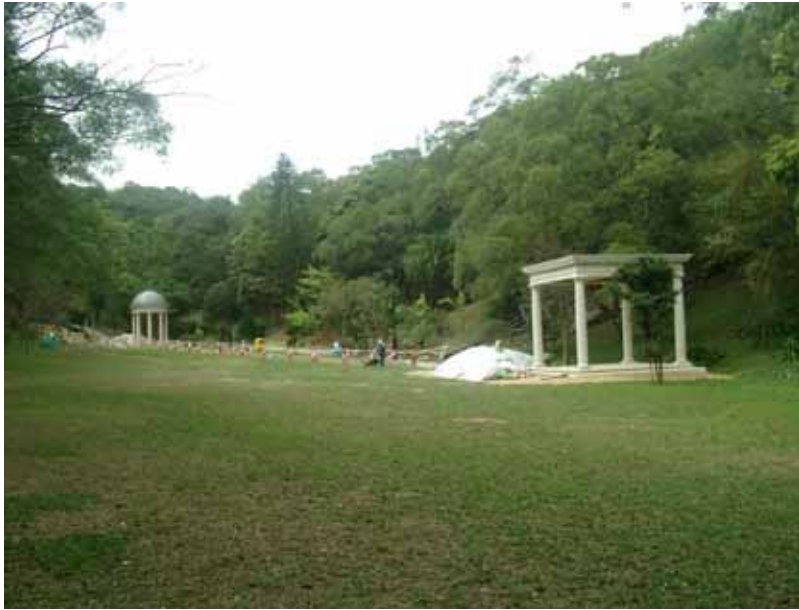
The area surrounding the Gate Lodge includes a serene open space with a seasonal stream running through it. It is primarily used by local residents as a sitting out area or to walk their dogs. A gazebo and rotunda are the latest addition to the open space.

11. Open space behind the Gate Lodge with a rotunda, gazebo and pathway under construction

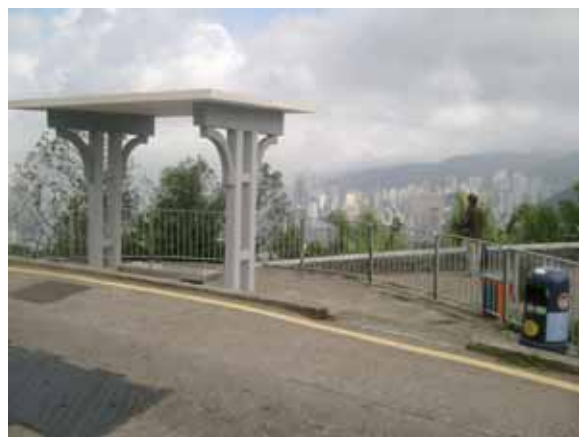
A small viewing pavilion located at the intersection of Mount Austin Rd and Lugard Rd offers a rest stop after a steep climb about one-third of the way to the FML precinct. While unassuming in appearance, it is at an historic pavilion dating from before 1920.

14. Viewing pavilion

The re-painting, improving of signage and improving of the sitting area were proposed in the recent improvement plan.

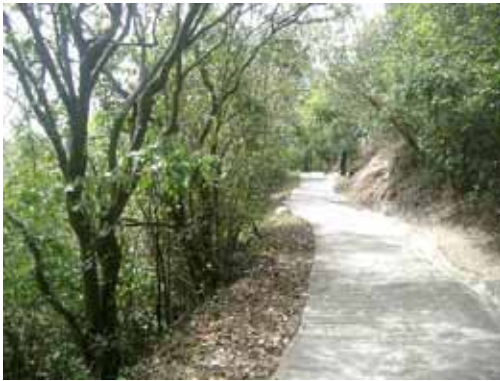
15. Start of path

In general, walking trails in the area (including the Governor's Walk) are defined by poured concrete paths that become quite narrow in some places with steep fall offs on the flanking edges. Some safety railings have been constructed, but may need to be extended in certain areas to improve safety before families can visit. However, the general approach should be to minimize the introduction of railings and other visual clutter that detracts from the natural setting. Improvements may also include removal of existing railings where practicable and where deemed unnecessary. The use of natural surfacing materials and soak-ways is highly recommended in lieu of unsightly expanses of concrete.

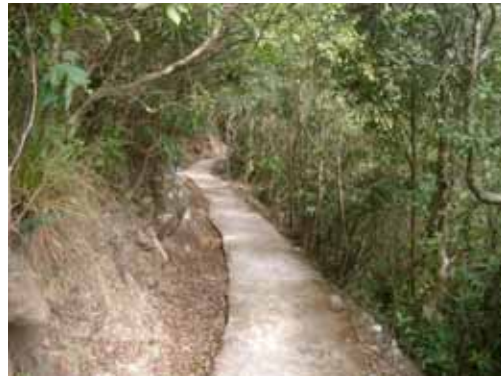
16. Narrow trail mid path with steep drop offs

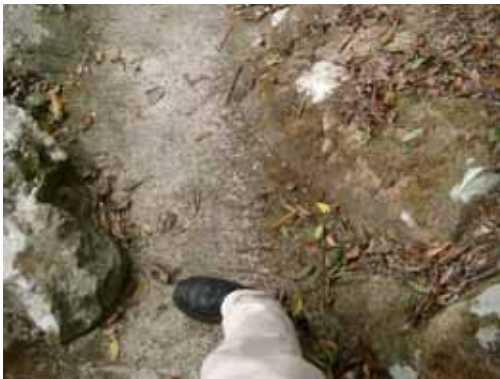
17. Width of trail at its most narrow

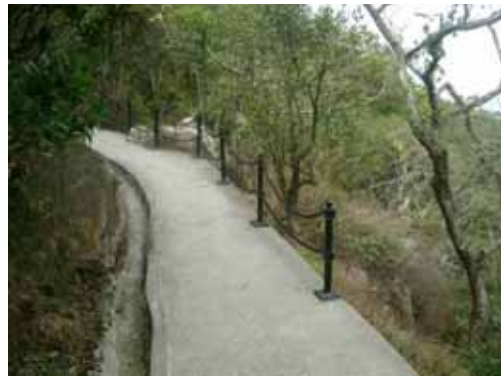
18. Railing work commencing

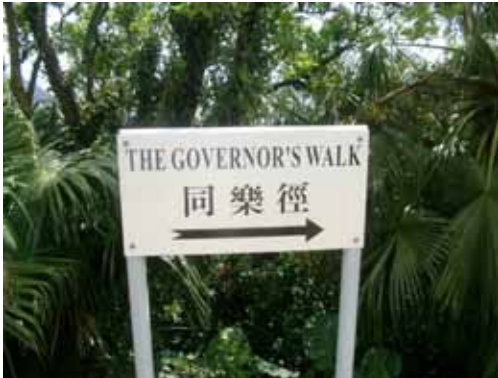
19. New Signage of Governor's Walk

At present, signage needs to be improved.

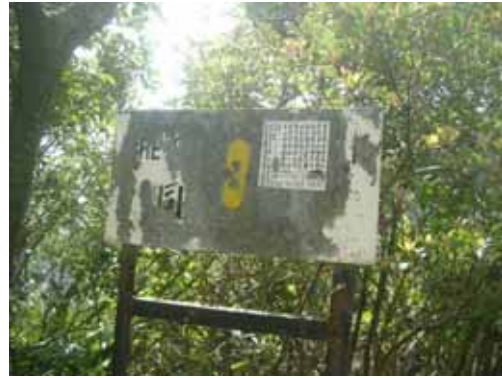
20. Signage needing repair of Governor's Walk

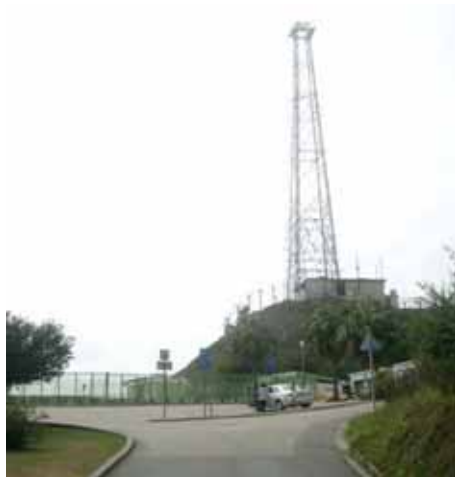
Two other, more modern features can also be found in close proximity to the FML. The first is a prominent communications' tower located directly adjacent to the FML including the adjacent building at No.40 Austin Road. The building previously functioning as an operations centre for the telecom utilities currently serves as a site office of the park management of the FML site.

21. Communication facilities adjacent to FML

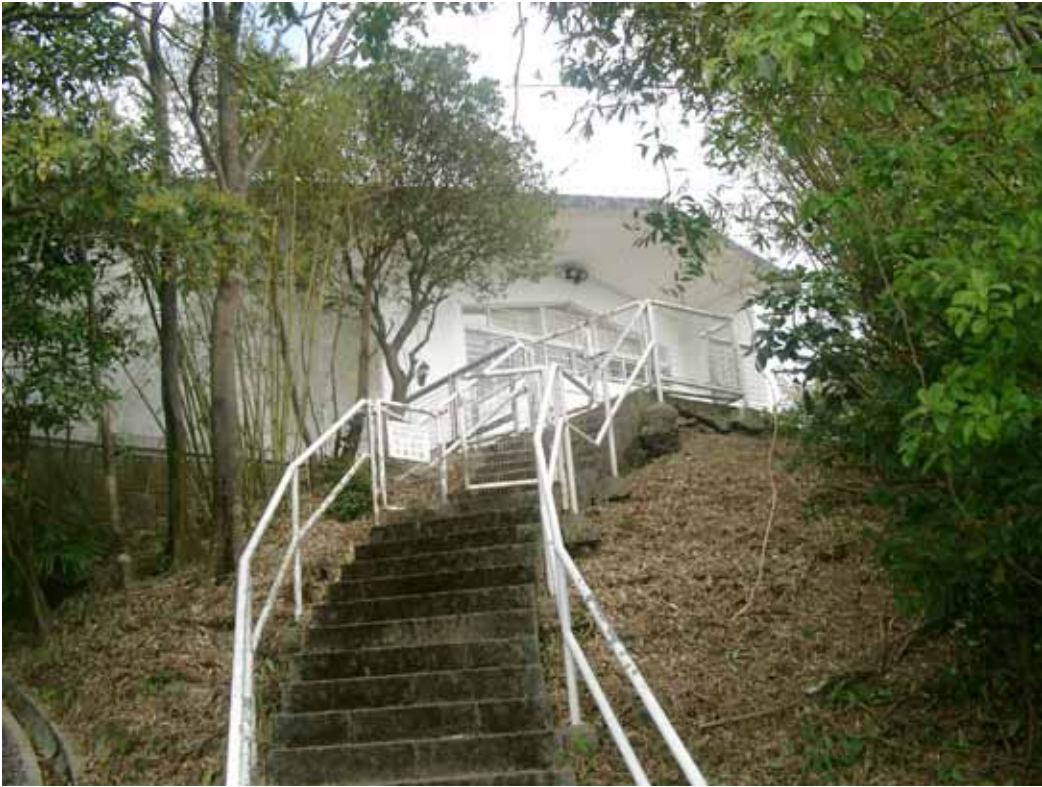
The second feature is what appears to be an abandoned house at No.36 Austin Rd. This is a substantial 1950s to 1970s private residence located above the FML.

23. No. 36 Mount Austin Rd house

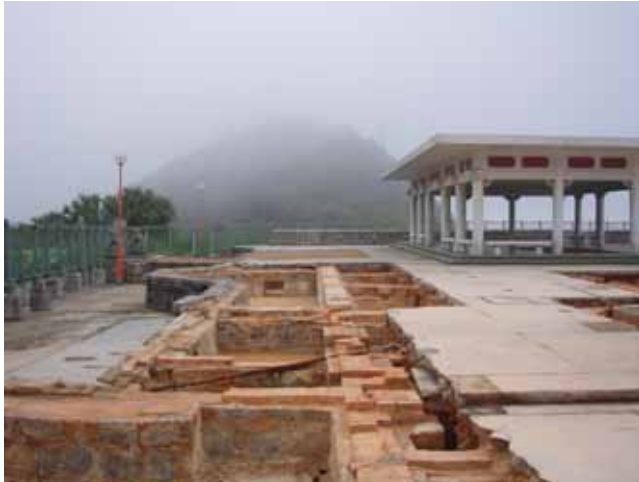
1. Foundation of Former Mountain Lodge (FML) (LDS & LHY)

Photo of Foundation of Former Mountain Lodge (FML)
(Source : Oval Feb 2009)

The foundations of the FML (referring to the second FML, which was constructed from 1900 to 1902), a Victorian mansion, occupy what can arguably be called the most prominent building site on the Peak. They include the outer exterior wall foundation (granite) of the main building, the interior wall foundations (brick) of the main building, and the exterior and interior wall foundations (brick) of the servants' quarters – sites A and B. In addition to the archaeological remains of the exterior and interior foundations of the main building, there are considerable remains of imported English tiles. The porch floor tiles, in particular, are noteworthy as they are generally intact and of high quality.

Significance: The foundations of the FML, including those of the main building and the two servants' quarters, have high evidential value. The tile paving of the porch floor of the main building has moderate aesthetic value.

Recommendation: Preserve.

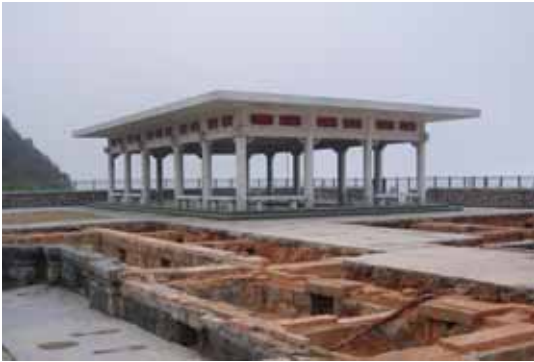
2. Pavilion by the former Urban Council (LDS & LHY)

Photo of Pavilion
(Source : Oval Feb 2009)

The extant pavilion (1970s) by the former Urban Council rests on part of the area defined by the exterior wall foundation of the main building of the FML. The pavilion, a reinforced concrete structure, is composed of a stepped platform, columns dignified by reference to *dou gong*, a perimeter beam with recessed rectangular panels framed by Chinese-inspired moldings and a canopy slab. The pavilion provides shelter for a broad range of user groups, including school children.

Recommendation: Preserve / modify selectively.

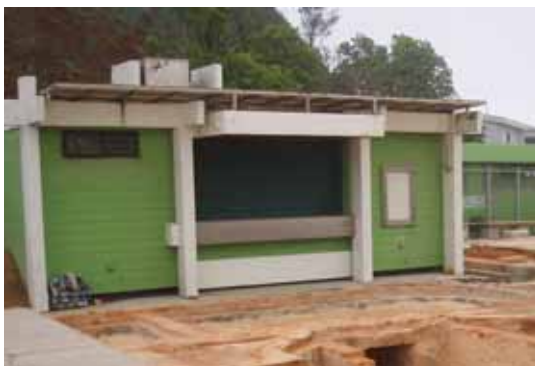
3. Kiosk (LDS & LHY)

Photo of Kiosk
(Source : Oval Feb 2009)

The kiosk sits to the northwest of the foundations of the main building of the FML. Of modest size and simple construction (concrete), the one-storey structure of recent construction provides a venue for light refreshment for Peak visitors.

Recommendation: Review long-term benefit and relevance to the site.

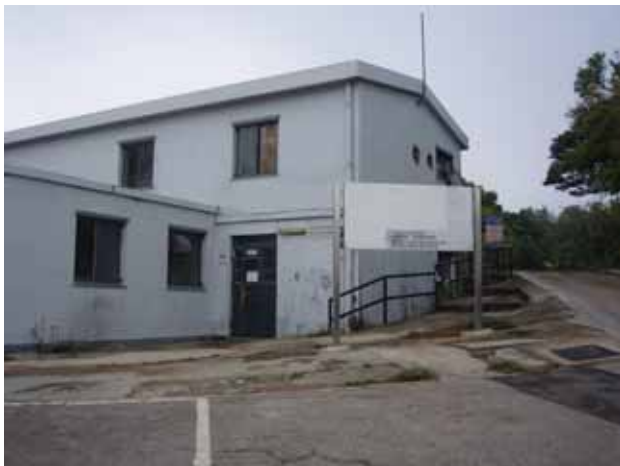
4. No.40 Mount Austin Road
(LDD & LHY)

Photo of No.40 Mount Austin Road
(Source : Oval Feb 2009)

No.40 Mount Austin Road (constructed after 1958) sits slightly to the northwest of the foundations of the main building of the FML. Irregular in plan and possibly built in stages, the one to two-storey utilitarian building is of post and beam concrete construction with brick infill. The west façade, which faces the foundations of the former servants' quarters – site B, is pleasing in its distribution of door and window openings. The building is part of Rural Building Lot No. 1087, which was leased by Hong Kong Telecom International Limited. (The lease has expired.)

Recommendation: Demolish subject to review of long-term benefit and relevance to the site.

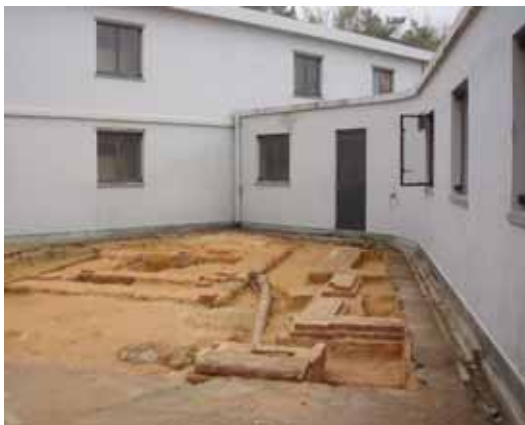
5. Foundations of former servant quarters- site A
(LDS & LHY)

Photo of Foundations of former servant quarters- site A
(Source : Oval Feb 2009)

The foundations of the FML include the outer exterior wall foundation (granite) of the main building, the interior wall foundations (brick) of the main building, and the exterior and interior wall foundations (brick) of the servants' quarters – sites A and B.

Significance: The foundations of the FML, including those of the main building and the two servants' quarters, have high evidential value.

Recommendation: Preserve

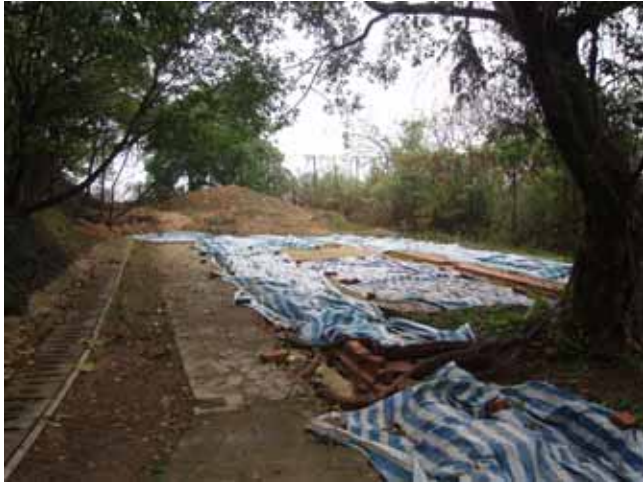
6. Foundations of former servant quarters- site B
(LDS & LHY)

Photo of Foundations of former servant quarters- site B
(Source : Oval Feb 2009)

The foundations of the FML include the outer exterior wall foundation (granite) of the main building, the interior wall foundations (brick) of the main building, and the exterior and interior wall foundations (brick) of the servants' quarters – sites A and B.

Significance: The foundations of the FML, including those of the main building and the two servants' quarters, have high evidential value.

Recommendation: Preserve

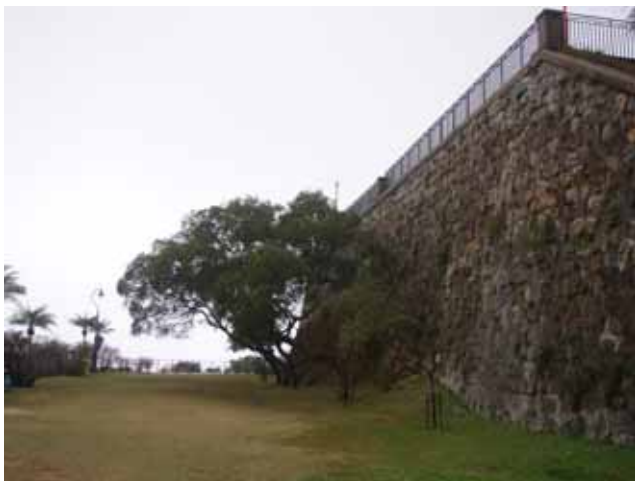
7. Retaining wall in Victoria Peak Garden
(LDS & LHY)

Photo of Retaining wall in Victoria Peak Garden
(Source : Oval Feb 2009)

The retaining wall is parallel to the southeast exterior foundation of the FML and is suitably set back to allow a satisfying garden link between the now demolished “north” and “south” elevations. The massive wall is constructed of roughly quarried granite with consistently well-pointed joints of appropriate scale. The granite coping on the wall is noteworthy.

Recommendation: Preserve.

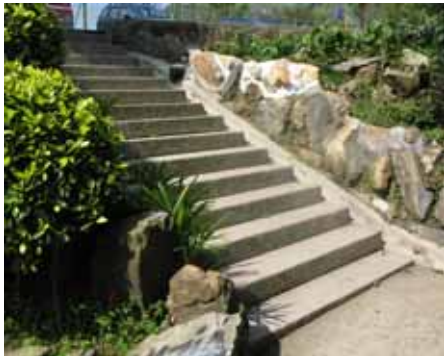
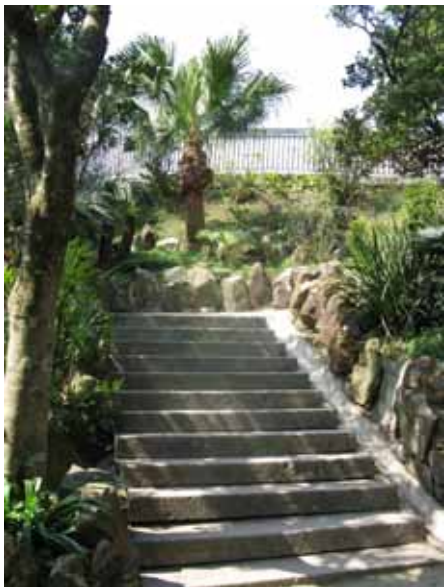
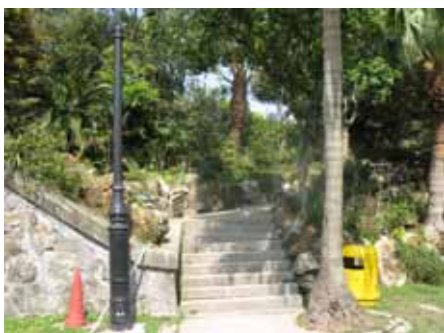
8. Zigzag Footpath Steps between car park and Victoria Peak Garden
(KN)

The zigzag footpath between the car park and the upper lawn of the Victoria Peak Garden includes three flights of broad, single-piece, natural granite steps that are in good condition. The low, random patterned, stone walls, which retain the soil alongside the path, have been partially repaired in recent years.

Photo of Steps between car park and Victoria Peak Garden
(Source : Oval Feb 2009)

Recommendation: Preserve.

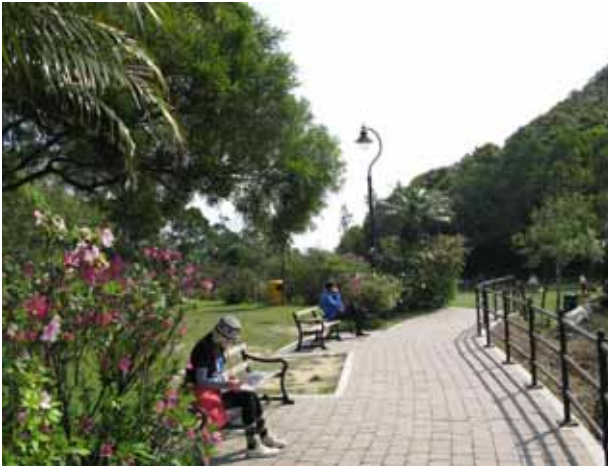
9. Circulation (Footpath)
(KN)

Photo of Footpath
(Source : Oval Feb 2009)

The footpath connecting the Victoria Peak Garden to the Governor's Walk has been repaved in recent years with colored concrete blocks.

Recommendation: Preserve.

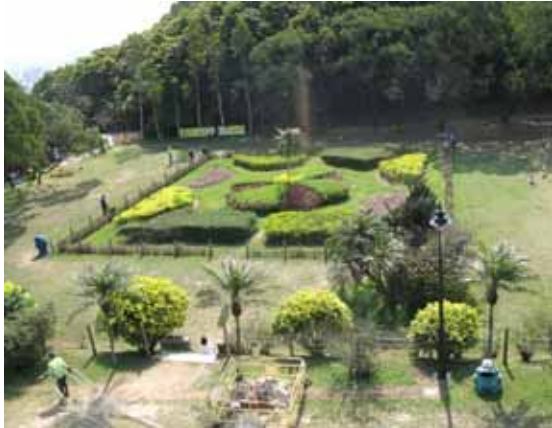
11. Victoria Peak Garden (Upper Lawn)
(KN)

Photo of Victoria Peak Garden (Upper Lawn)
(Source : Oval Feb 2009)

Victoria Peak Garden (or upper lawn area) comprises a lawn area with ornamental shrubs and trees. The lawn area provided space for tennis games and picnics for residents and guests of the FML. The lawn is popular today with the public for exercising dogs, having picnics and playing games. The central shrub bed is a relatively recent addition and conflicts with the original intention of this open space as an open lawn.

Recommendation: Preserve / modify selectively.

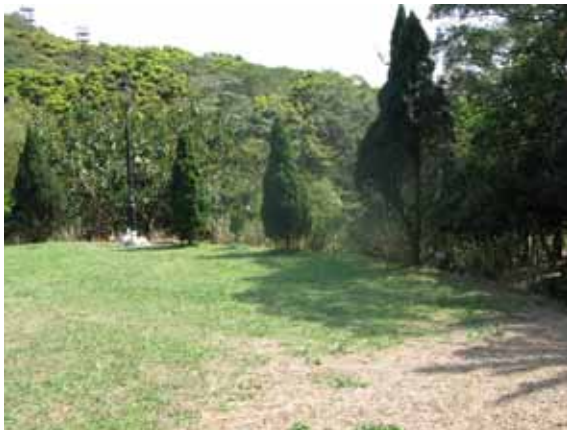
12. Garden (Middle Lawn)
(KN)

Photo of Garden (Middle Lawn)
(Source : Oval Feb 2009)

This second garden (or middle lawn) comprises a relatively secluded lawn area enclosed by woodland and connected by footpath to the Victoria Peak Garden above and the lower lawn area below. Like Victoria Peak Garden, this lawn area is now used by the public for dog exercising and picnics. Areas of freely- accessible open lawn are relatively rare in Hong Kong.

Recommendation: Preserve / modify selectively.

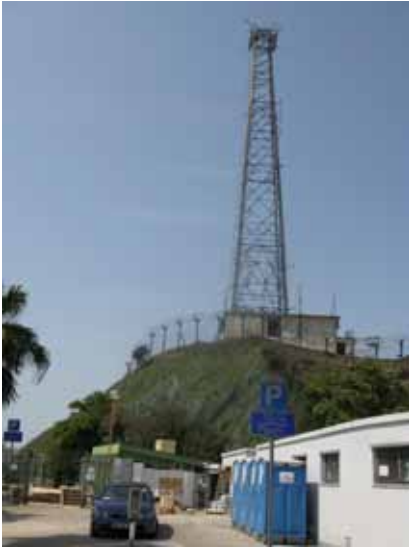
13. Radio Tower
(LDD & LHY)

Photo of Radio Tower
(Source : Oval Feb 2009)

The radio tower is located at the top of a small peak immediately to the northwest of the FML and is one of a series of masts and towers on peaks that ring the site. The tower is part of Hong Kong's radio-telecommunications system and was leased by Hong Kong Telecom International Limited (part of Rural Building Lot No. 1087). (The lease has expired.)

Recommendation: N/A.

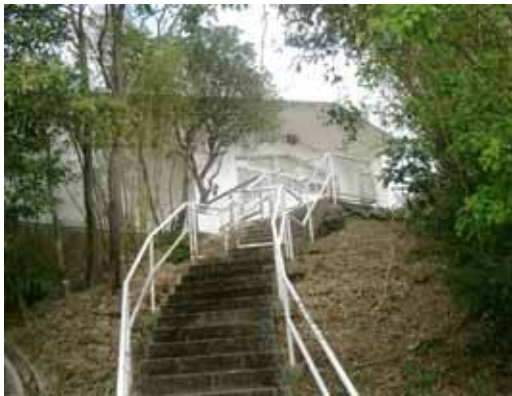
14. No.36 Mount Austin Road
(LDS & LHY)

Photo of No.36 Mount Austin Road
(Source : Oval Feb 2009)

No.36 Mount Austin Road (constructed after 1958) sits on a small outcropping to the north of the foundations of the main building of the FML. Slightly irregular in plan, the decidedly domestic one-story building appears to be in reinforced concrete. The building is part of Rural Building Lot No. 1087, which was leased by Hong Kong Telecom International Limited. (The lease has expired.)

Recommendation: N/A

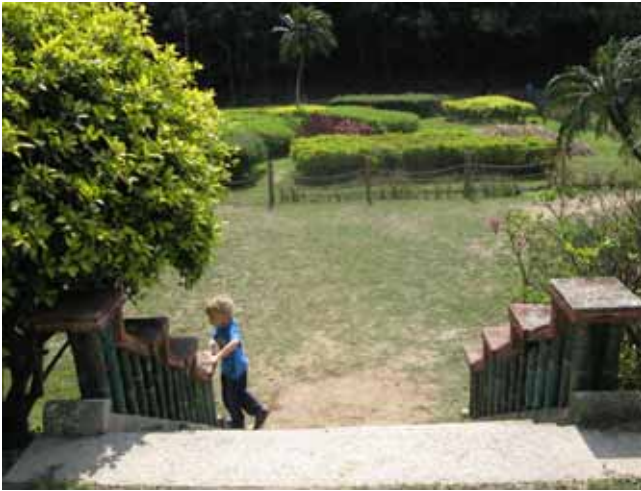
15. Staircase in Victoria Peak Garden
(KN)

Photo of Staircase in Victoria Peak Garden
(Source : Oval Feb 2009)

The short staircase between the upper and lower lawn platforms within Victoria Peak Garden comprises natural granite steps with more recent additions of Chinese style ceramic handrails and balusters.

Recommendation: Preserve / modify selectively.

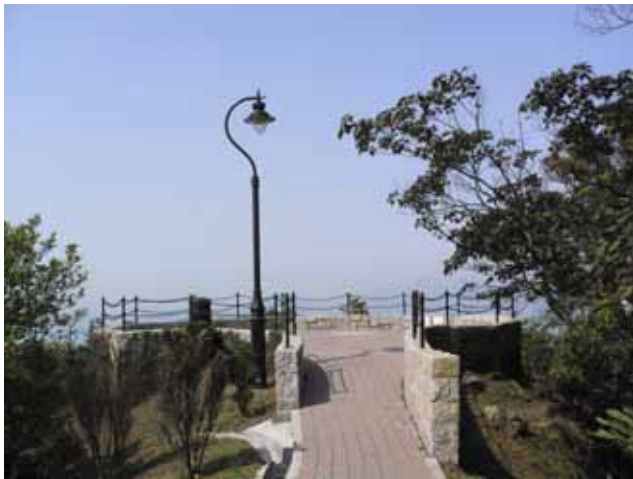
16. Circular Viewing Platform
(LDS & LHY)

Photo of Circular Viewing Platform
(Source : Oval Feb 2009)

The current viewing platform is of recent construction, although the location of the platform dates from at least the 1920s.

Recommendation: Preserve / modify selectively.

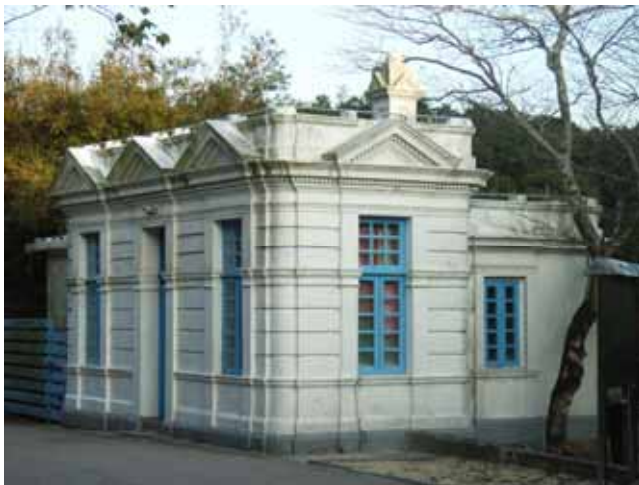
17. Gate Lodge
(LDS & LHY)

Photo of Gate Lodge
(Source : Oval Feb 2009)

The Gate Lodge (completed in 1902 with the second FML) sits at the original entrance to the FML and its extensive grounds. Symmetrical in elevation and T-shape in plan, the one-story stuccoed brick building is Classical in design – and Scottish in its sturdy appearance. Sadly, the original gate posts and gate have disappeared. The structure is recognized as a Declared Monument (1995).

Recommendation: Preserve.

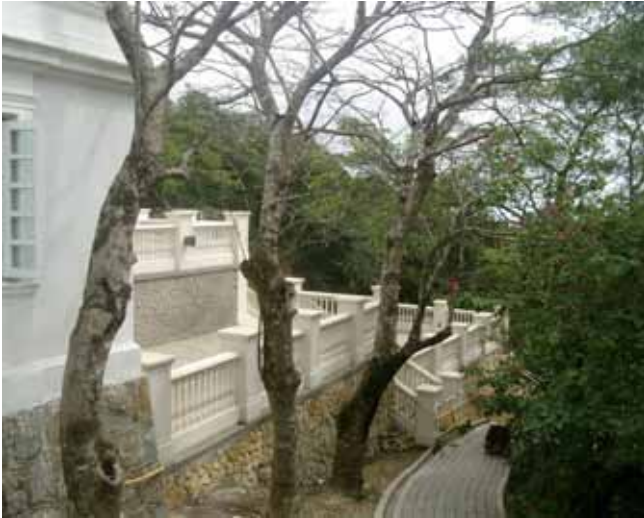
18. Terrace
(KN)

Photo of Terrace
(Source : Oval Feb 2009)

The recently constructed set of terraces behind the Gate Lodge comprise concrete and natural stone finishes and are assumed to be installed to provide a sitting out area for visitors to the Gate Lodge. It was newly added to the Gate Lodge.

Recommendation: Modify selectively.

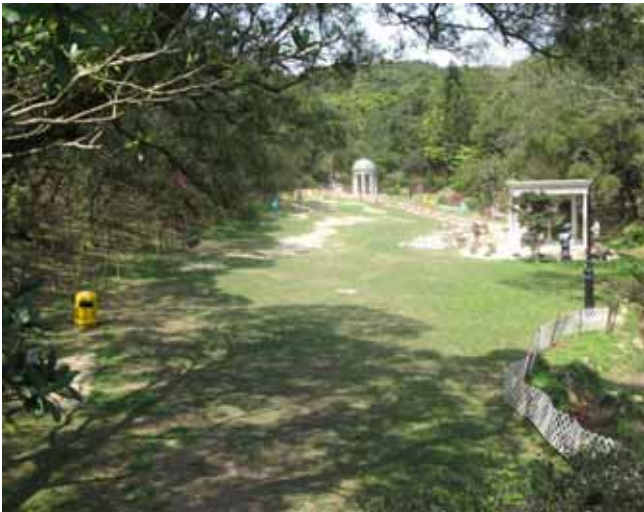
19. Garden (Lower Lawn)
(KN)

Photo of Garden (Lower Lawn)
(Source : Oval Feb 2009)

This third garden comprises the lower lawn area, which is relatively secluded but freely accessible for the public to exercise dogs and have picnics and informal games. The original character of the lawn has been adversely impacted by the recent introduction of new rain shelters in the form of a rotunda and gazebo (refer 20 and 21).

Recommendation: Preserve / modify selectively.

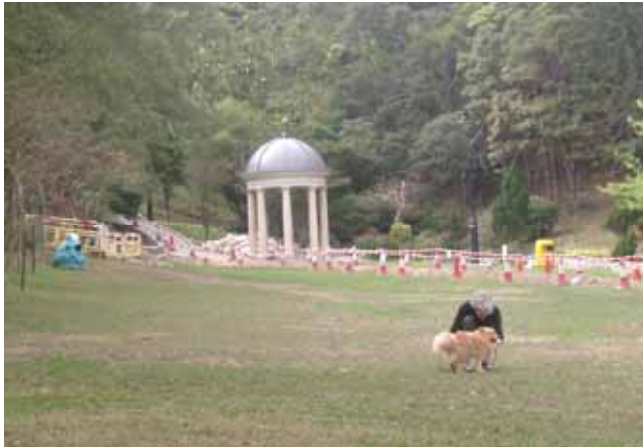
20. Rotunda
(LDS & LHY)

Photo of Rotunda
(Source : Oval Feb 2009)

The rotunda is located toward the middle of the lawn area (19. Garden), which is at the east side of the grounds of the Former Mountain Lodge. It is a diminutive structure of recent construction and loosely based on Classical forms.

Recommendation: Review long-term benefit and relevance to the site.

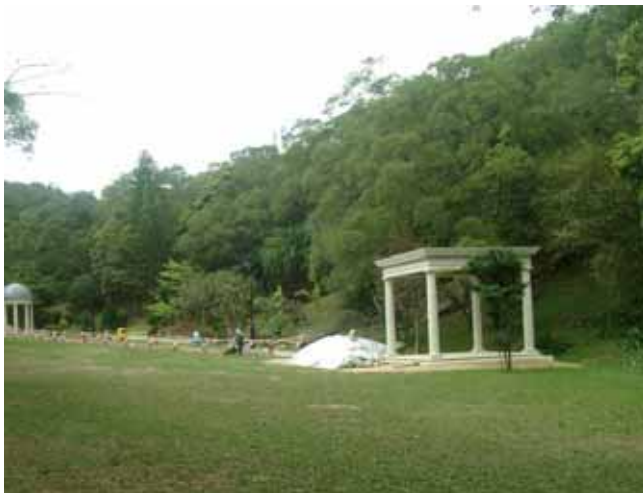
21. Gazebo
(LDS & LHY)

Photo of Gazebo
(Source : Oval Feb 2009)

The gazebo is located near the western end of the lawn area (19. Garden), which is at the east side of the grounds of the Former Mountain Lodge. It is a diminutive structure of recent construction and loosely based on traditional garden forms.

Recommendation: Review long-term benefit and relevance to the site.

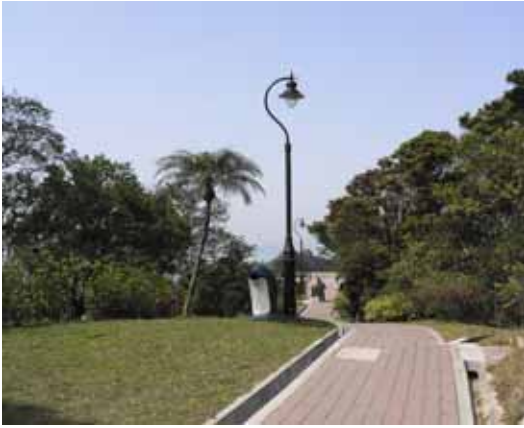
22. Governor's Walk
(KN)

The current Governor's Walk follows the alignment of that shown on plans dating from the 1920s. It has been resurfaced over time in concrete with more ornamental (colored concrete block) paving and handrails installed along portions closest to the former Mountain Lodge. The path is very narrow in places and winds through woodland and includes some attractive viewpoints.

Recommendation: Preserve / modify selectively.

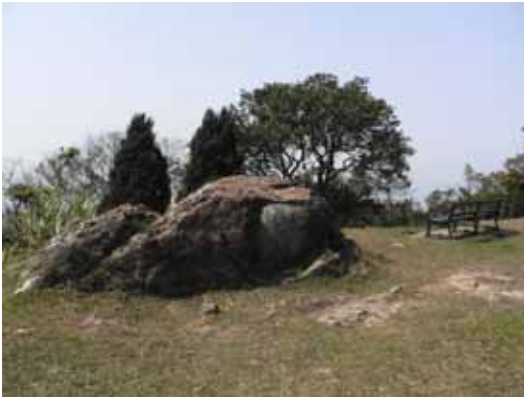
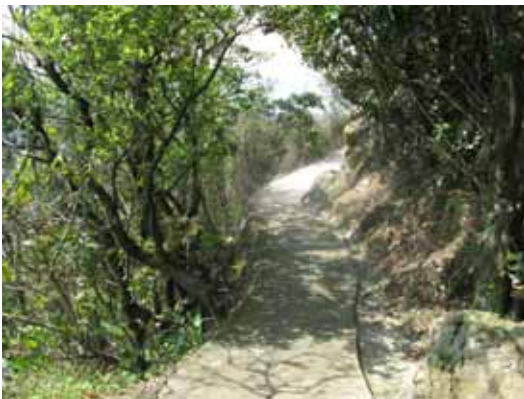
Photo of Governor's Walk
(Source : Oval Feb 2009)

Significance: The Governor's Walk has moderate landscape architectural value and high social value.

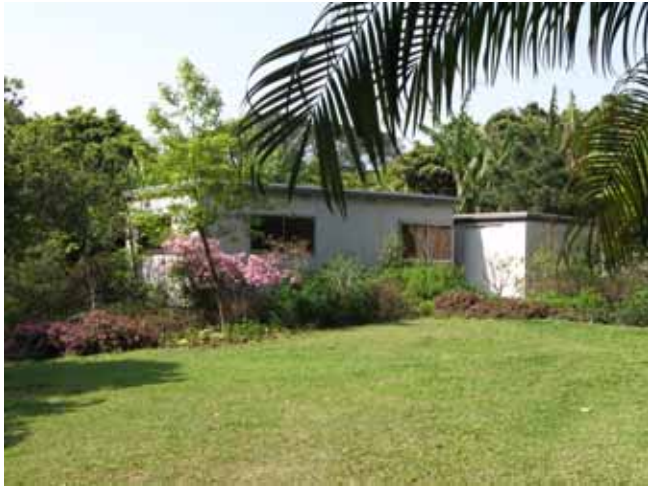
23. Government Stores
(LDS & LHY)

Photo of Government Store
(Source : Oval Feb 2009)

The government store is located within the grounds of the FML and is to the northwest of the lawn area (19. Garden), which is at the east side of the grounds. It is a modest one-storey utilitarian structure of recent construction.

Recommendation: Modify selectively.

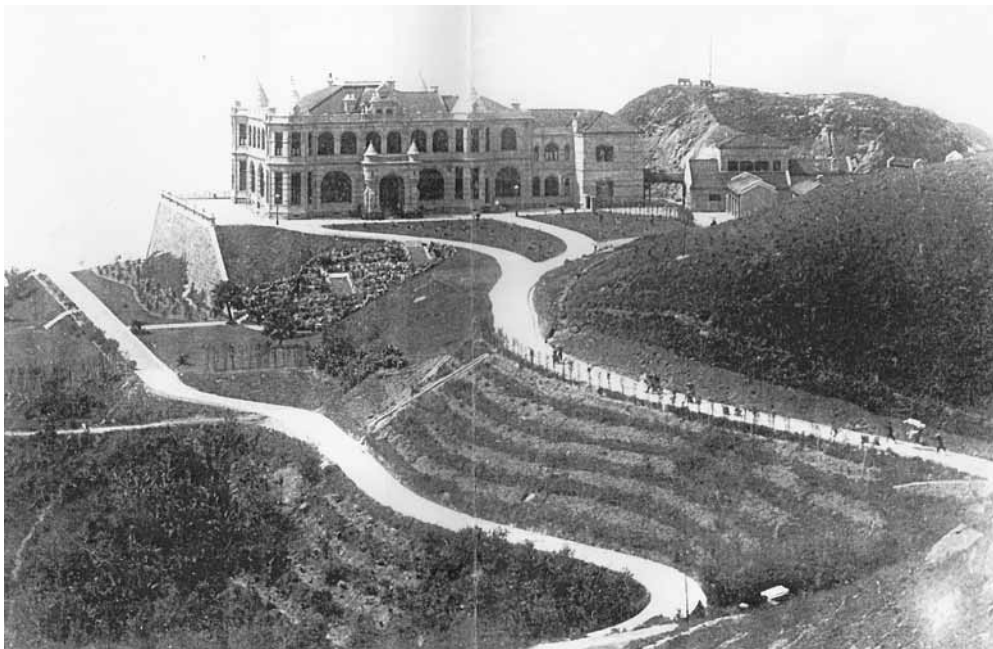
The Lodge was constructed on a formed platform retained on the south-west and south-east sides by a large stone wall straddling a rock outcrop. At the time of completion the nearby slopes were sparsely covered with mainly grass and scrub vegetation and a few trees. However, there does appear to be deliberate planting work in progress as suggested by the regular rows (typical of forestry operations) of tree seedlings on upper slopes. Slopes close to the Mountain Lodge, alongside the access road (Mount Austin Road) also show signs of being terraced with shrub planting.

Visible at this time is a zig-zag footpath that provides a more direct connection between the Mountain Lodge and the lawn area. A block of ornamental planting has been provided on either side of this path that resembles a rock garden. The more ornamental planting in this location would have a sunny south-east aspect and protection from north and west winds in the lee of the building platform.

4. View of Mountain Lodge circa 1903 showing slope planting between and below the access roads with apparent new tree planting on upper slopes. (Courtesy of Public Records Office)

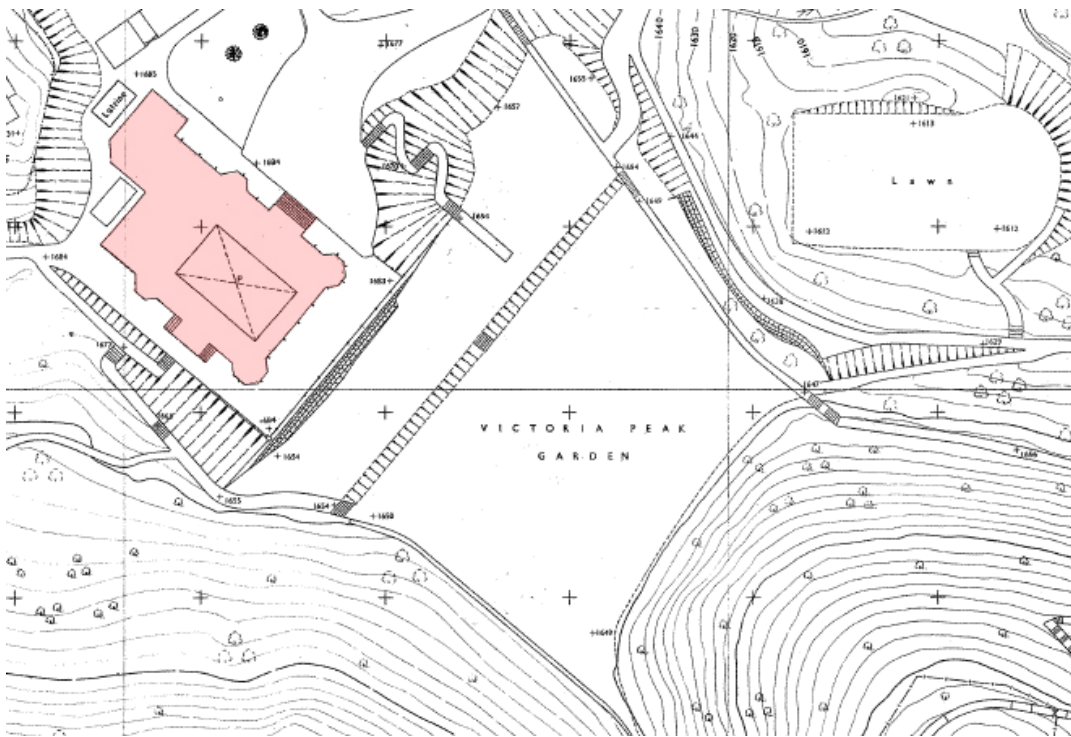
Comparison between the 1922 and 1973 site plans shows that, although the Mountain Lodge was demolished and replaced with a concrete pavilion, the general landscape character did not change significantly during this period. The terraces, slopes, and footpath / road circulation pattern are much the same with a few notable exceptions, namely: the trees that used to shelter the former tennis courts have gone, the planted area in front of the FML is now a car park and cartographic tree symbols now indicate that woodland has established on the surrounding hillside.

7. 1973 Plan of the FML (highlighted), now partly replaced by the existing pavilion and the area of lawn adjacent, now named Victoria Peak Garden.

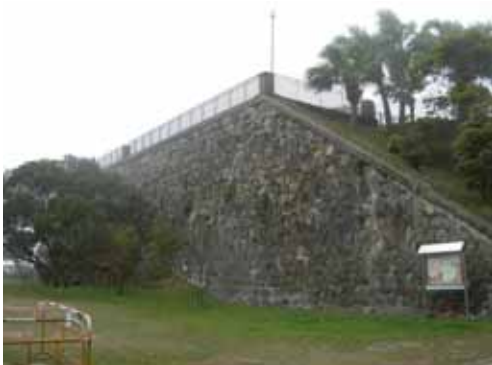
These walls are excellent examples of their kind and show a high degree of craftsmanship in their construction. However, localized repairs are required to match with the original stonework and jointing.

11. Whole view of the retaining wall

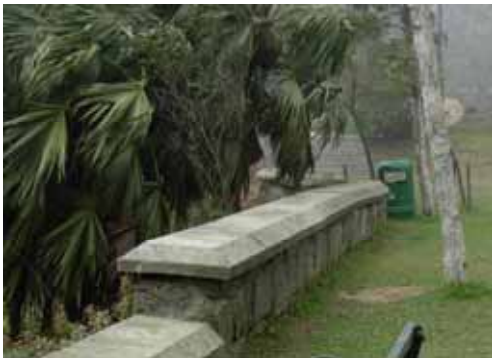
13. The granite garden wall

The impressive granite coping on this wall is unusually large and displays some of the former grandeur of the Mountain Lodge.

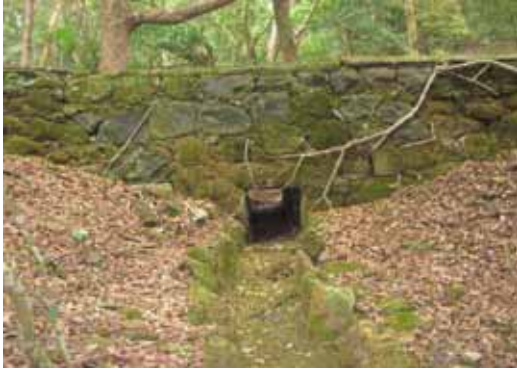
The stone walls, culverts and drainage channels are exquisitely constructed and in relatively good condition.

15. Stone retaining wall

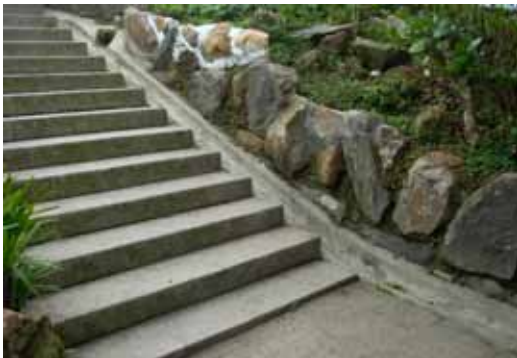
17. Granite steps

The path follows the original alignment and the three flights of granite steps are still in good condition. However, localized repairs are required to match with the original stonework and jointing.

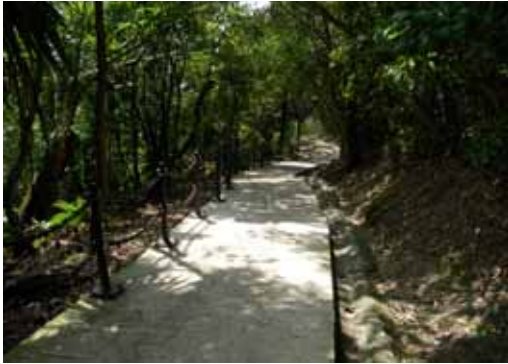
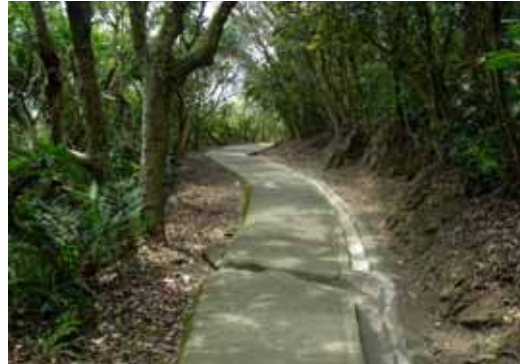
The existing footpath follows the original alignment although it has been concreted throughout its length with portions recently repaved with colored concrete paving blocks and installed with low railings.

19. Part of Governor's Walk (concreted)

20. Part of Governor's Walk (concreted)

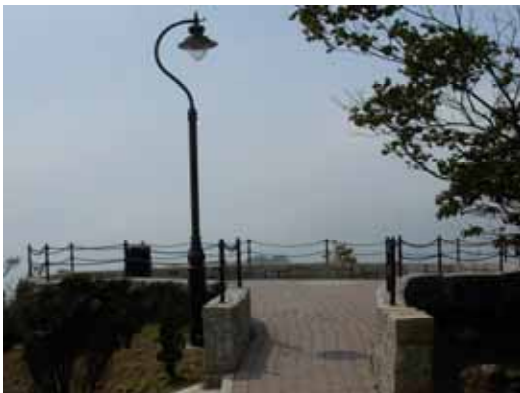
The circular viewing platform was established when the FML was built. However, the character is quite different today. Formerly just an area of level grass at the end of a footpath, the platform is now contained by a stone parapet and railing. The path has been recently repaved with colored concrete blocks.

21. Circular viewing platform

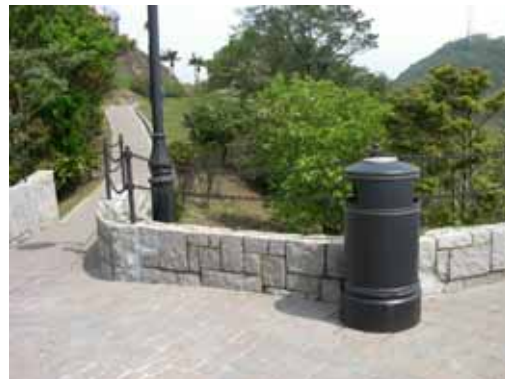
22. Access to circular viewing platform

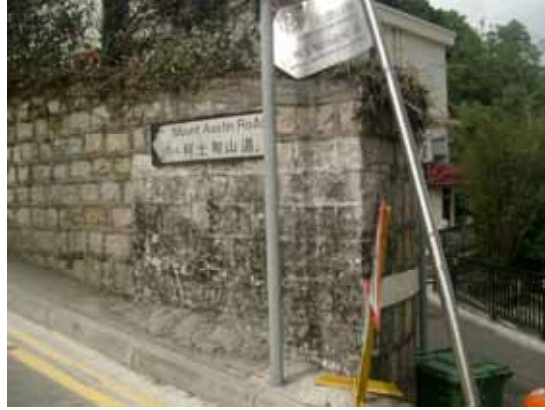
- Access is somewhat problematic and will need to be addressed.
- Existing signage needs to be improved.

1. Existing signage at Mount Austin Road

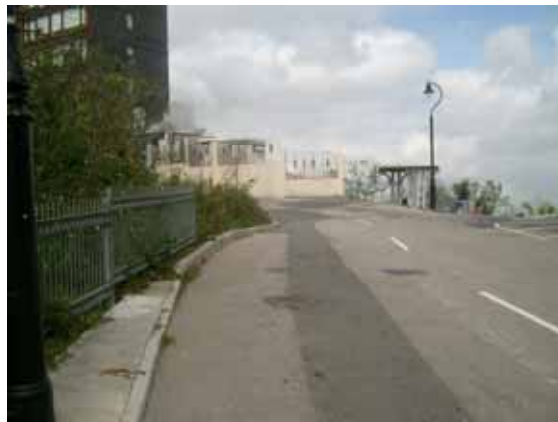
- The climb up to the FML is fairly strenuous (climbing up 100+ m) and can be quite uncomfortable in the summer. Visitors will require a certain level of fitness. During the site inspection, the consultant met a couple who decided to turn back at the viewing pavilion because of the strenuous nature of the walk.
- Access involves walking along Mount Austin Road. Sidewalks are variable in width and then disappear in places. One option is to develop a footpath linking Mount Austin playground with the Victoria Peak Garden. Different options were explored and rejected, noting certain challenges regarding the steep gradient of the slope, geotechnical issues and the potential felling of tree requiring further study. Improvement and enhancement of sidewalks is required. However, further options may be explored.

2. Disappearing sidewalk at Mount Austin Road

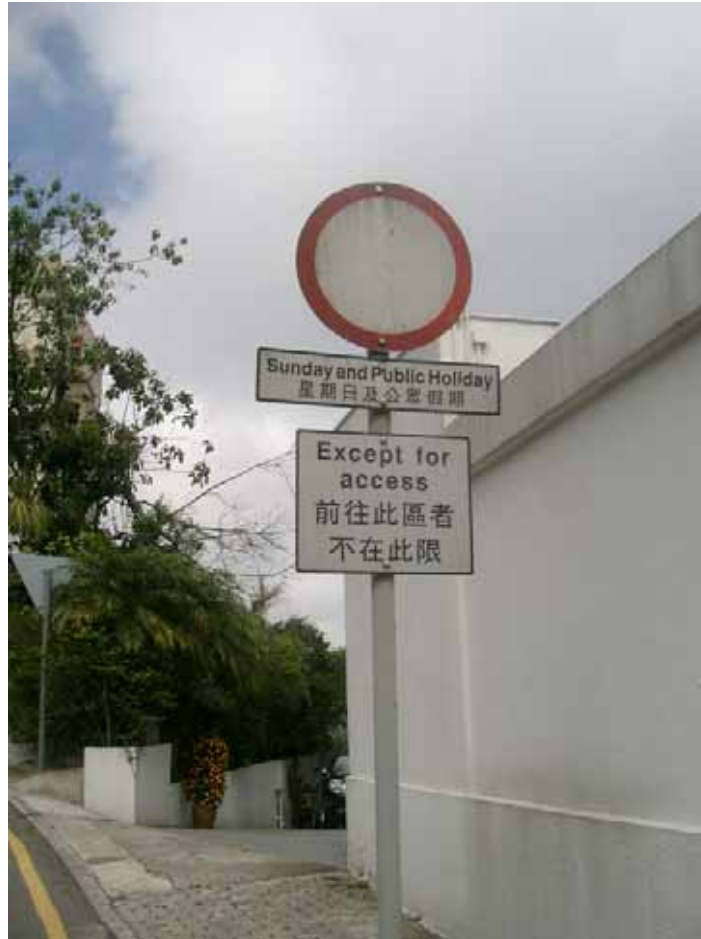
- Mount Austin Road itself is a single lane road that could become overcrowded quite easily. The upper reaches of the road are closed on Sundays and Public Holidays, further restricting access, while a police barricade is enforced at the Peak Tower area to restrict traffic during busy times.

3. Mount Austin Road. closed on Sundays and holidays
